The Upchurch Group, Inc.

05 September 2018

Re: Evaluation of Village Maintenance Building, 103 East 1st Street

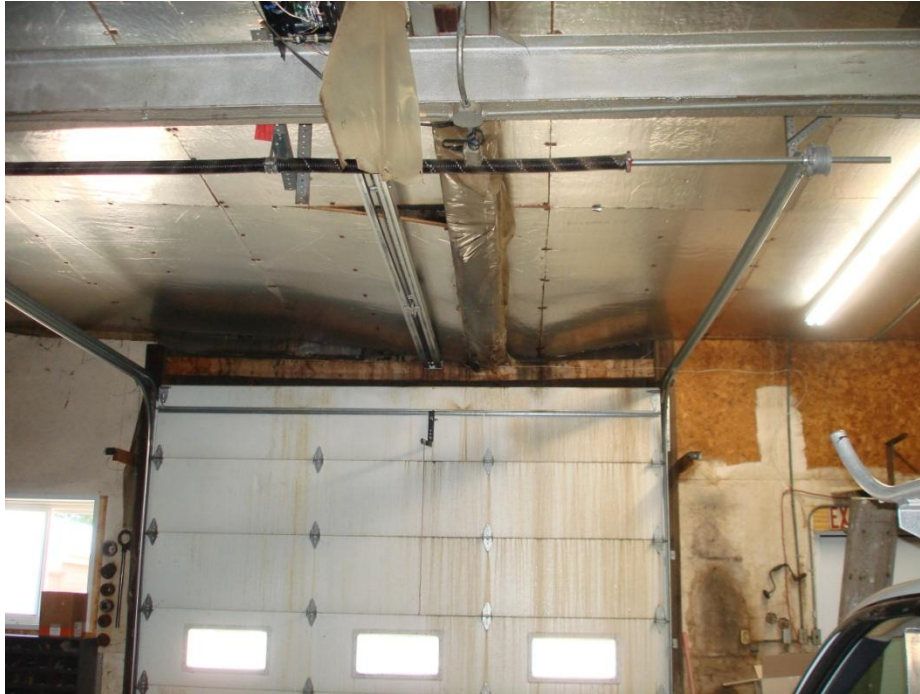
The southernmost section of a wood beam supporting the roof structure was observed to be broken allowing the section of the roof it supported to sag and interfere with operation of the overhead door. The wood beam, composed of four 2x boards laminated together, runs along the building's center line from the East 1st Street wall to the East 2nd Street wall, sloping downward from north to south. The ends of the wood beam are supported by the building's north and south walls. A series of wood posts spaced along the building's center line support

1. South wall interior at overhead door.

- i. Remove and salvage for re-use the overhead door operator, traveling rail, tracks, door panels, etc.
- ii. Remove ceiling covering and insulation material from south bay.
- iii. Install temporary supports for rafters on east and west sides of beam in south bay.
- iv. Demolish existing section of center beam from steel frame support to south wall.
- v. Remove interior covering from south wall over vehicle door opening.
- vi. Demolish and replace header beam if determined to be structurally compromised.
- vii. Install new center beam from steel frame to south wall.
- viii. Fasten rafters to new center beam and remove temporary rafter supports.
- ix. Re-install overhead door.

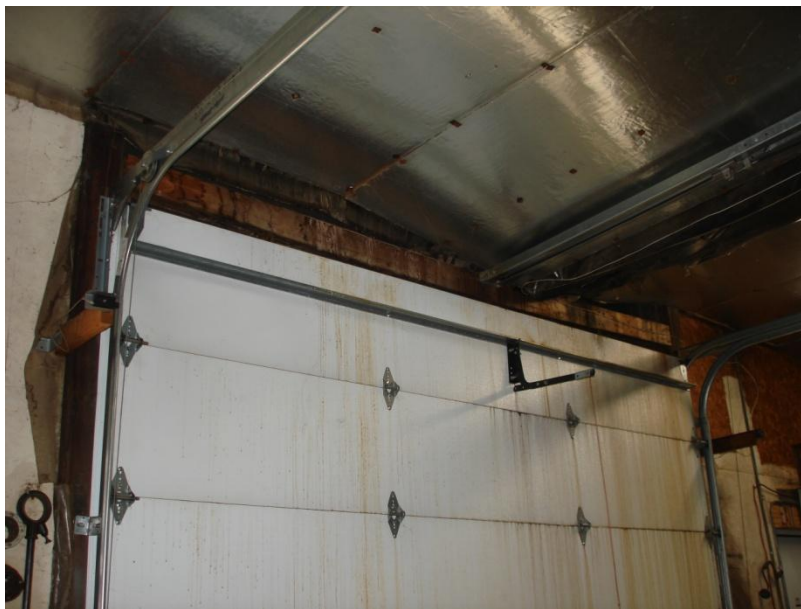
2. At overhead door in south wall.

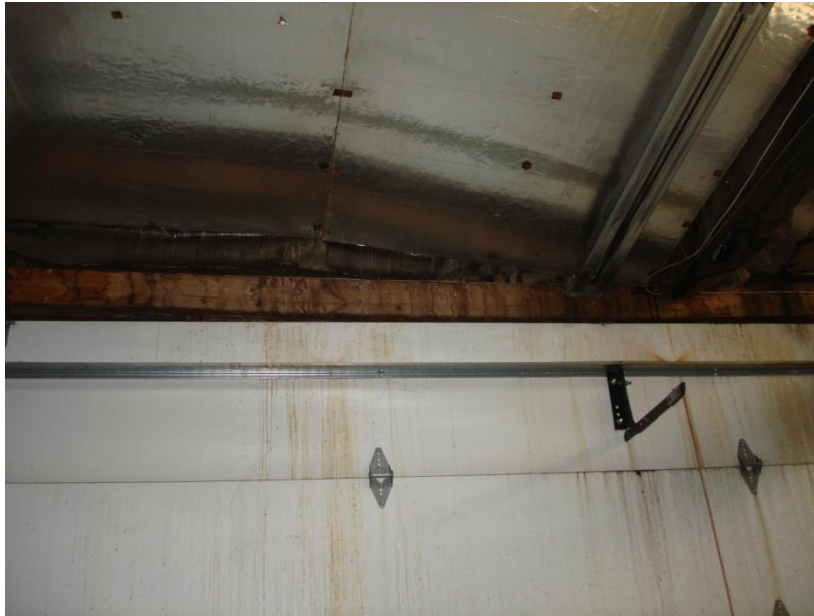
3. Detail view of collapsed ceiling above overhead door.

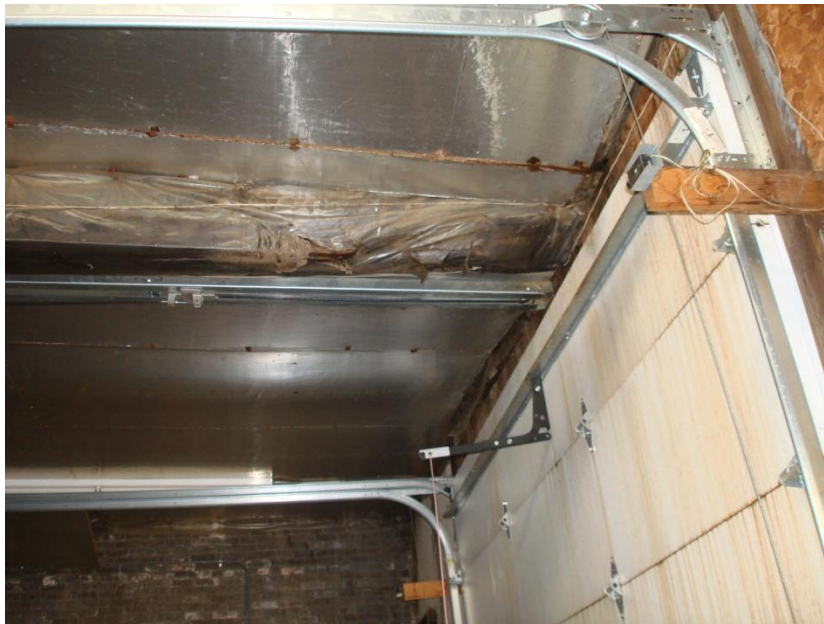
Plastic sheeting, presumably installed as a vapor barrier during an insulation upgrade, was observed wrapped around the sides and bottom of the wood beam. The plastic sheeting had trapped water that leaked through the roof. Prevented from draining away from the beam or evaporating, the trapped water resulted in perennially wet conditions at the low end of the beam. Wood decay and the corrosion of metal fasteners were observed when the plastic was removed from the low end of the beam. The actual break in the beam occurred about three feet north of the south wall where butt joints in two of the laminations produced a weak plane in the beam.

4. Detail view of broken beam.

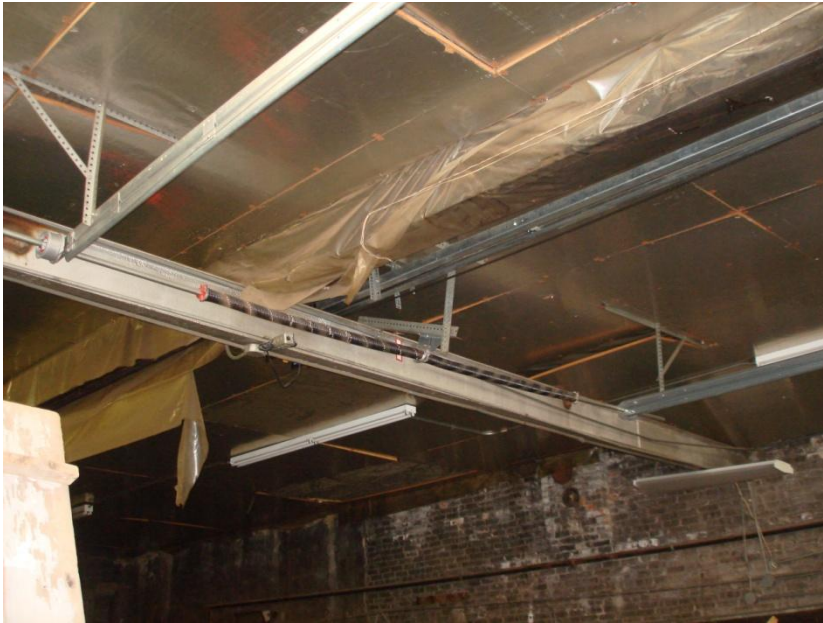
the beam between the end walls. A steel frame was installed at some time in the past to eliminate the southernmost post and open up space for a centrally located vehicle service bay.

5. Beam supported by steel frame.

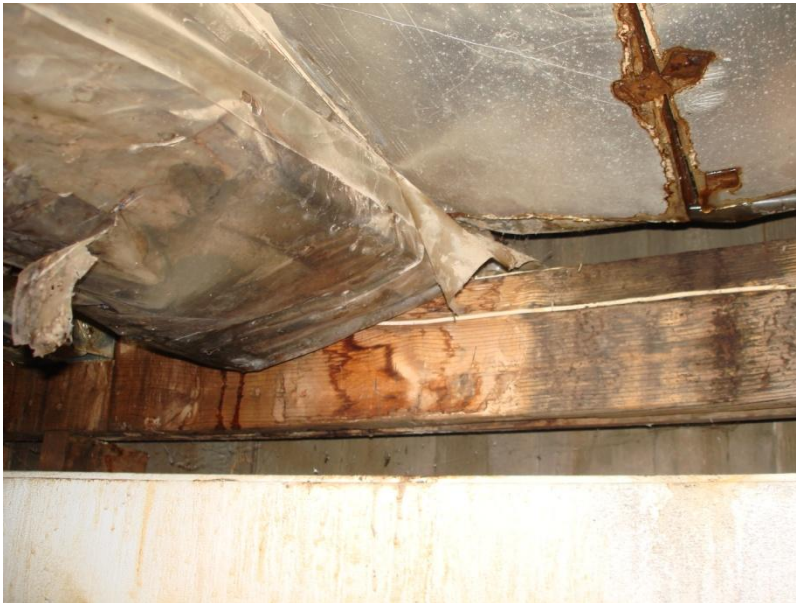
The original masonry wall that once faced East 2nd Street had been replaced with a wood frame wall featuring a large opening fitted with an overhead door for vehicle access. The interior face of the wall has been sheathed with oriented strand board (OSB) and the exterior has been finished with steel siding. One end of the failed structural beam is supported by this wood framed wall over the vehicle access opening. As observed post-failure, the end of the beam appears to be bearing on a 2x6 header over the opening, which is, in turn, deforming under the load and pulling its fasteners out of the jamb framing. Although it was not apparent during my observations, it is likely that the end of the beam had been supported by a more substantial header closer to the roof line, possibly supported using joist hangers.

6. Broken beam apparently bearing on and deforming header above overhead door.

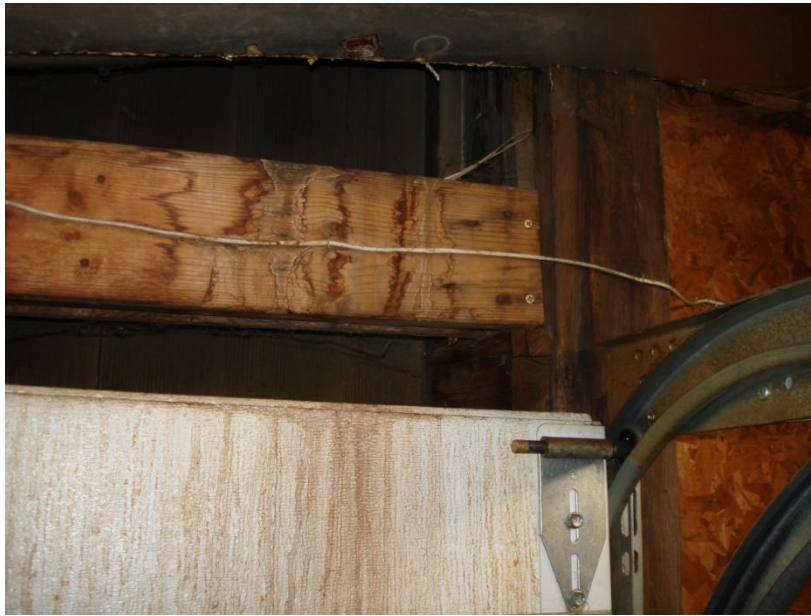
7. Fasteners at west end of header above overhead door pulling out of jamb framing.

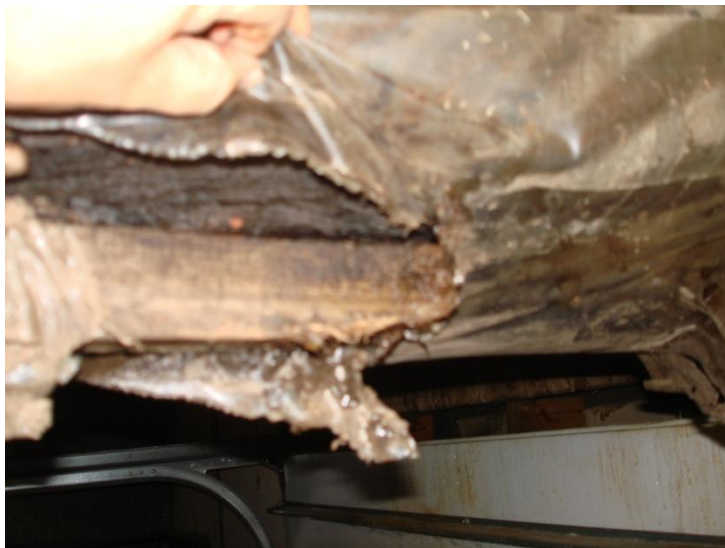
8. Plastic sheeting torn away to reveal break in beam and release trapped water.

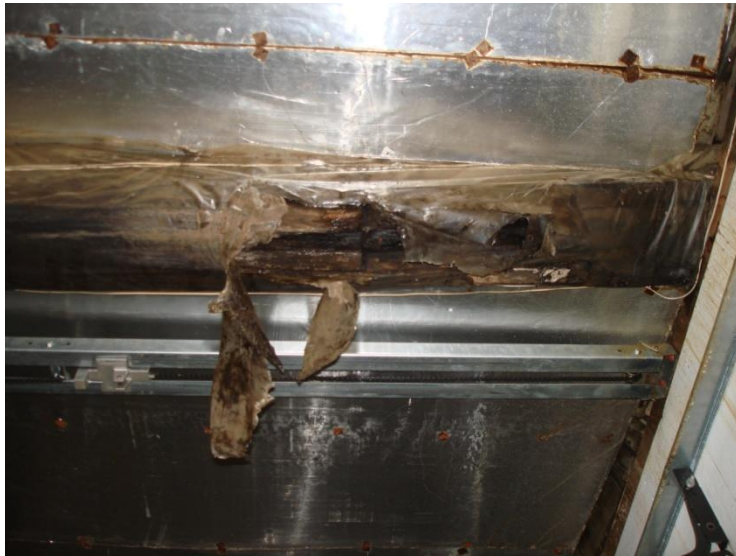
9. Plastic sheeting torn away at break in beam.

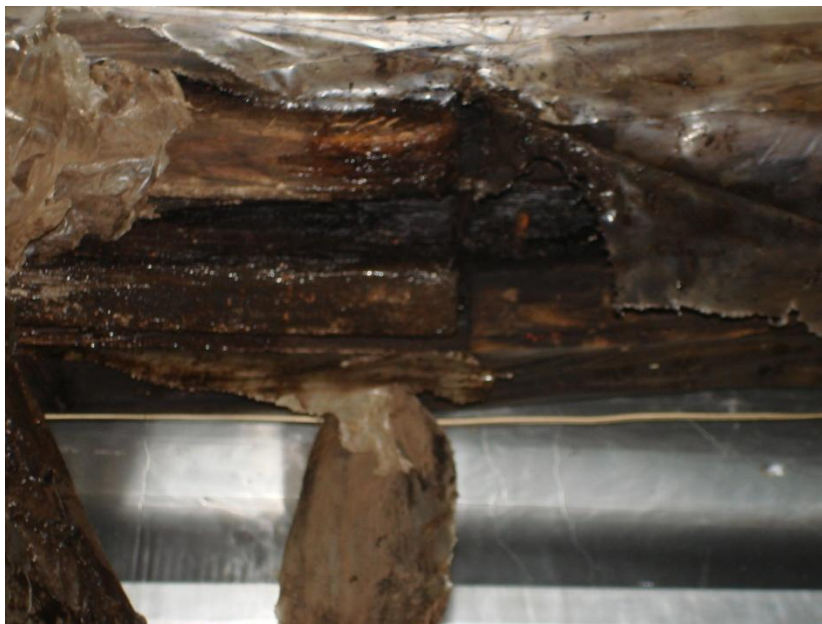
10. Rotted wood and corroded fasteners revealed at break in beam.

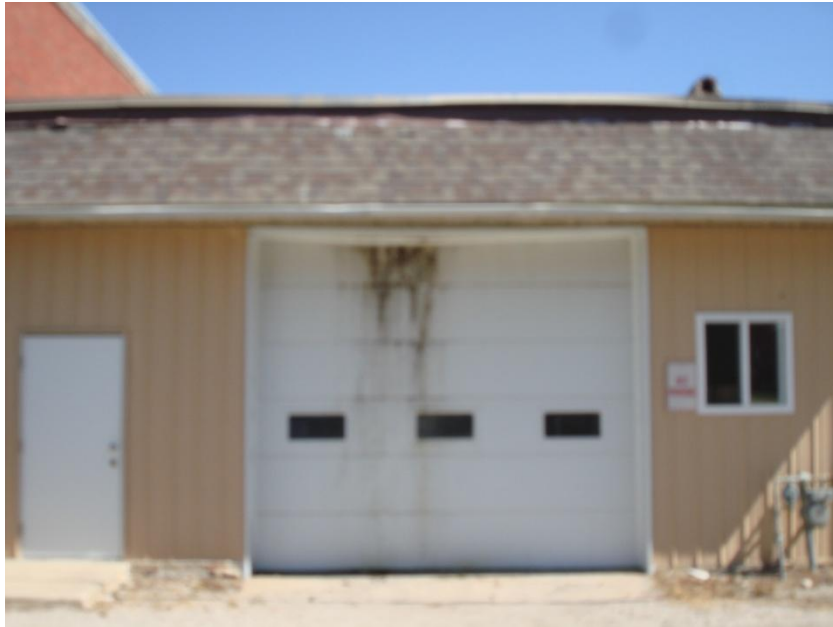
11. Roof eave distorted by collapse of beam and roof deck.

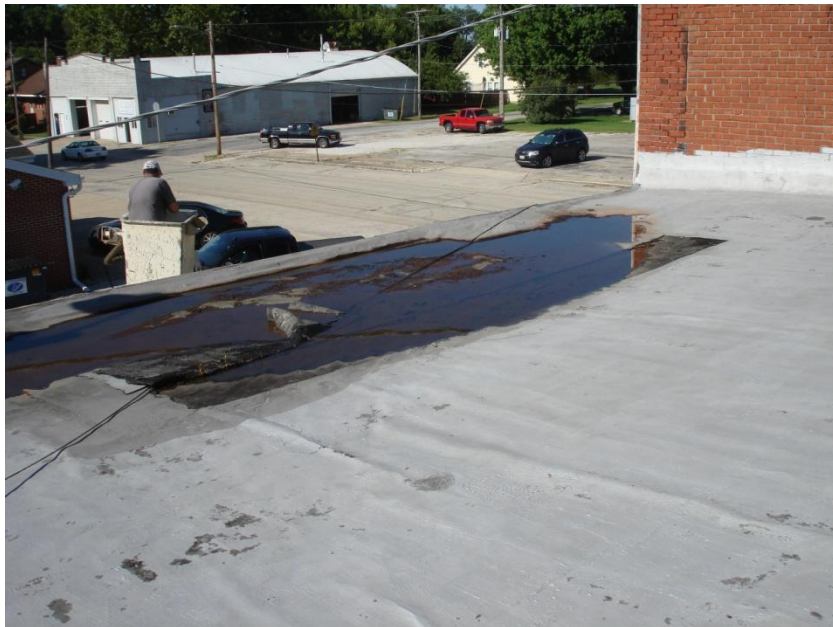
The area of the structural failure is very apparent on the roof. A depression has formed in the roof deck over the broken beam. It has filled with water. The built-up roofing material at the depression is torn and rolled back, appearing to be the result of wind damage that may have occurred prior to the structural failure. The roof eave has been deformed by the collapsing roof deck and now slopes in the wrong direction, directing water from the roof back into the wall system immediately above the overhead door opening.

12. Depression in roof above broken beam filled with water.

- i. Test roofing materials for the presence of asbestos and abate those materials found to contain asbestos.
- ii. Tear-off existing roofing and any roof decking that appears to be broken, warped, rotted, or water damaged.

- iii. Install new roof decking.
- iv. Install new roofing system:
 1. Double layer of perimeter 2x4" nailers.
 2. ½" Plywood backer boards applied to all vertical surfaces to receive membrane flashing from roof deck to reglet.

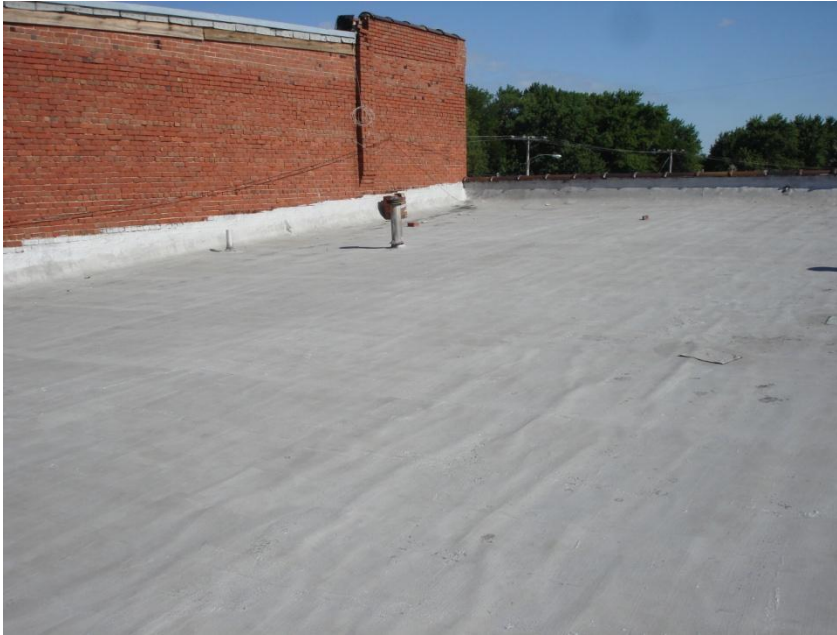
The roof had probably been leaking in multiple locations for a long time. Besides the obvious damage to the roof at the place where the structure has failed, the roofing is covered with blisters and the membrane flashings have become brittle and badly deteriorated. There are holes in the membrane flashings at the parapets big enough for small animals to enter.

13. Blisters across surface of roof.

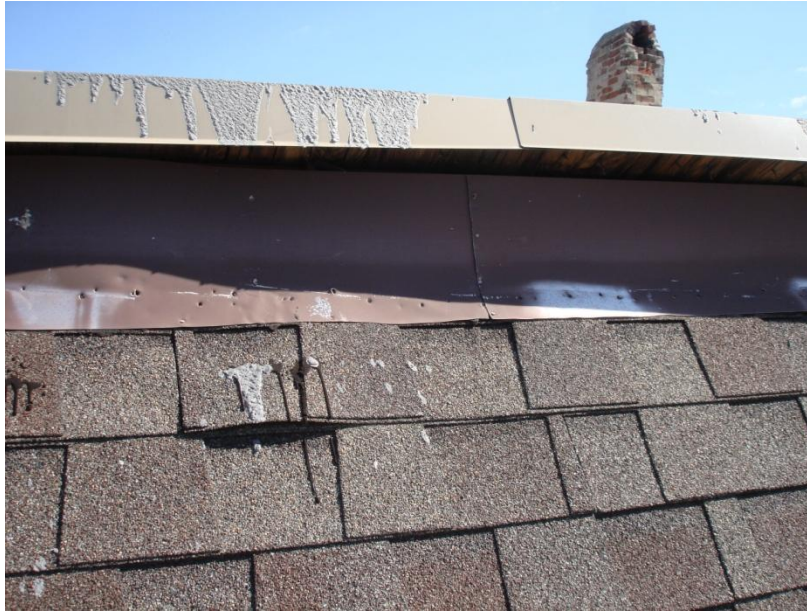
15. Roof eave distorted by collapsed beam and decking now drains up-hill.

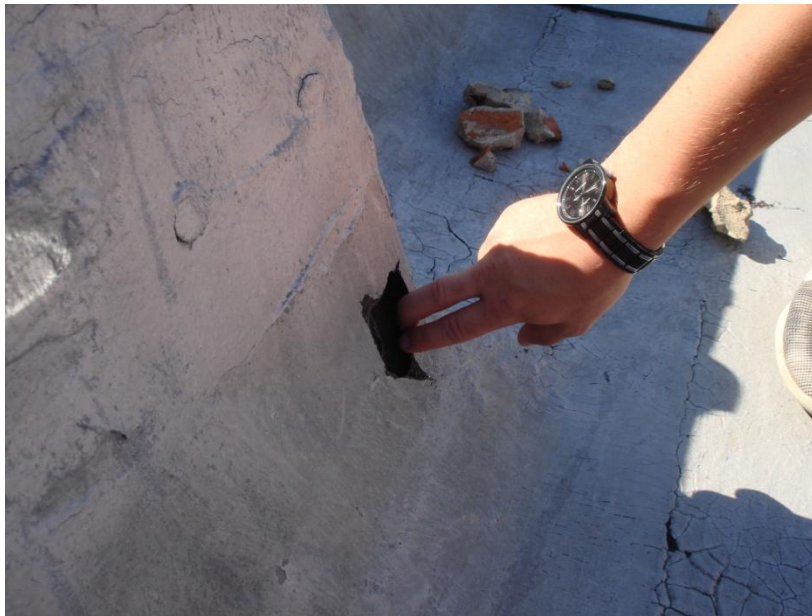
16. Membrane flashing, pulled away from parapet, has become brittle. Breaks in the flashing are large enough for small animals to enter.

5. ¼" Securock cover board set in insulation mastic.
 6. 60 mil EPDM roofing membrane – fully adhered.
 7. 60 mil EPDM membrane flashing – adhered to plywood backer boards and terminated with 1" continuous aluminum termination bars secured at 8" on center.

8. 2-piece pre-finished steel counter flashing to protect upper edge of membrane flashing.

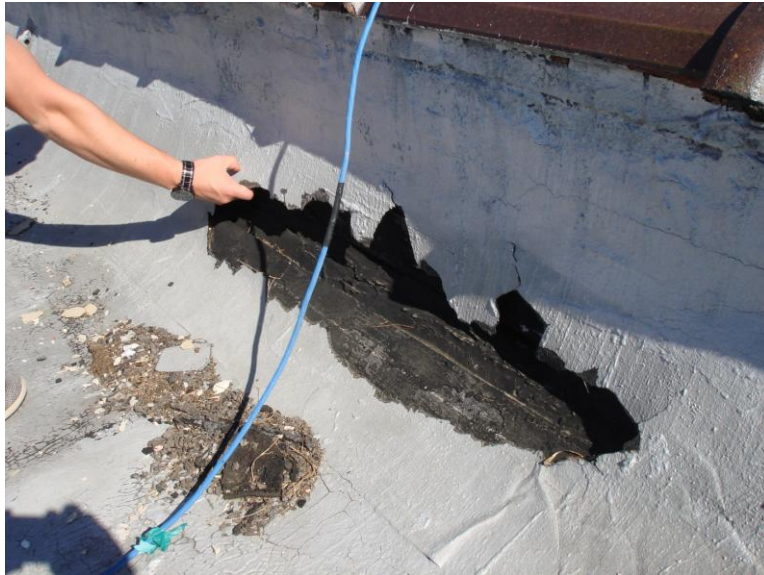
17. Membrane flashing pulled away from parapet, brittle, and broken.

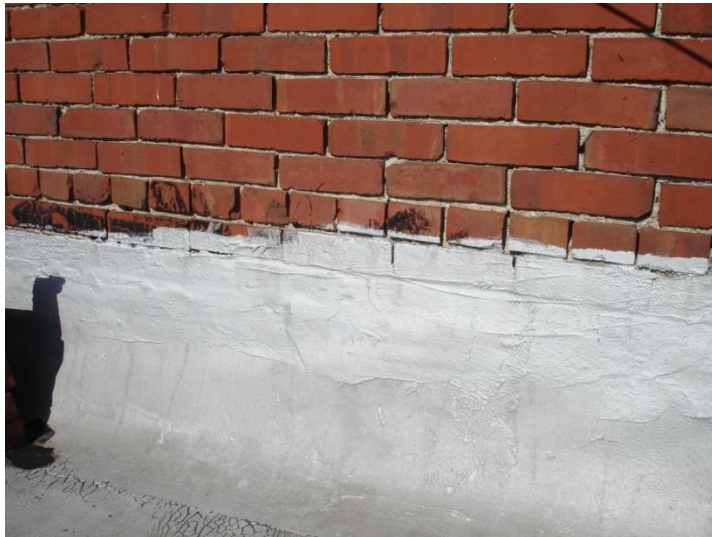
21. Detail view of membrane flashing at 2nd story wall.

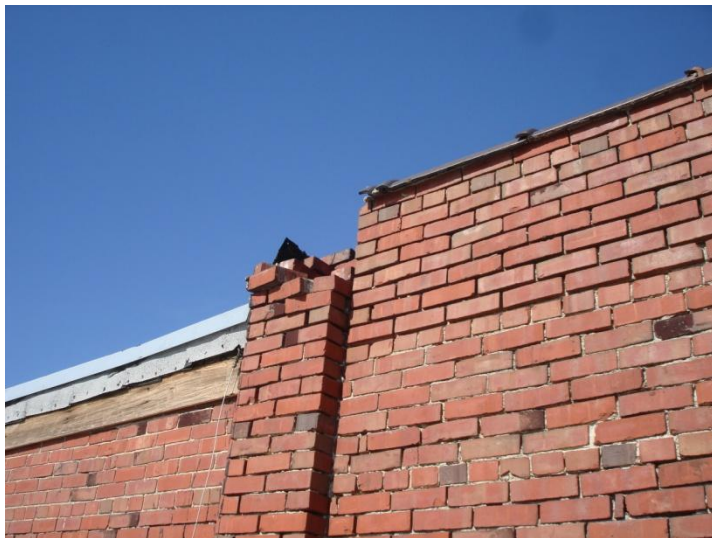
Disused chimneys built as part of the masonry walls have been abandoned without being properly closed. These chimneys provide an entrance for water into the building through their open flues and through the badly deteriorated masonry. Likewise, the deteriorated masonry in the second story wall above the membrane flashing provides another entry point for water into the building.

22. Detail view of 2nd story parapet condition.

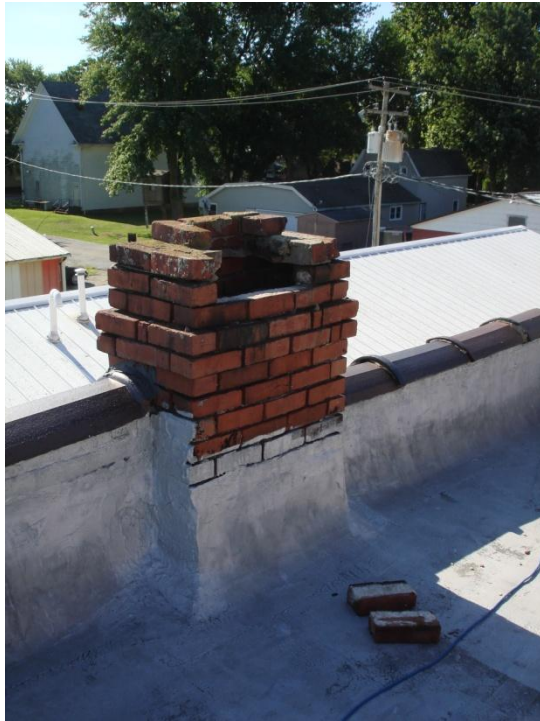
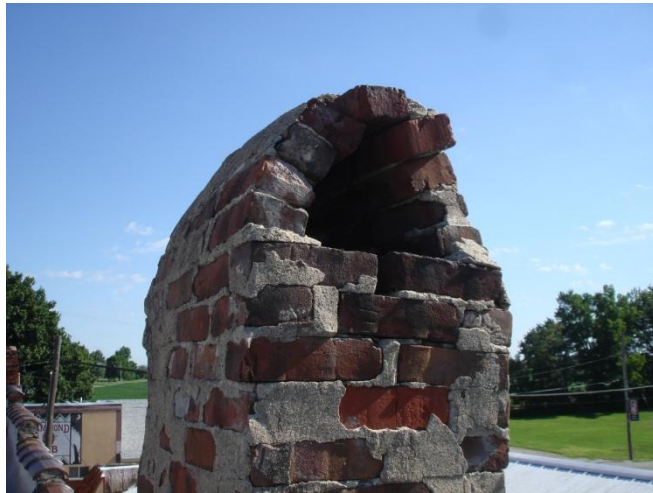
23. Detail views of disused masonry chimneys at east parapet.

- i. Tear down disused masonry chimneys to one course above highest adjacent coping.
- ii. Tuck point all exposed masonry joints on building exterior.
- iii. Install 2x and plywood closure cap over top of chimney so that the top slopes back toward the roof at ½" to 12".
- iv. Install a 60 mil EPDM membrane flashing over the entire wood construction.
- v. Install a pre-finished sheet metal cap over the membrane flashing.

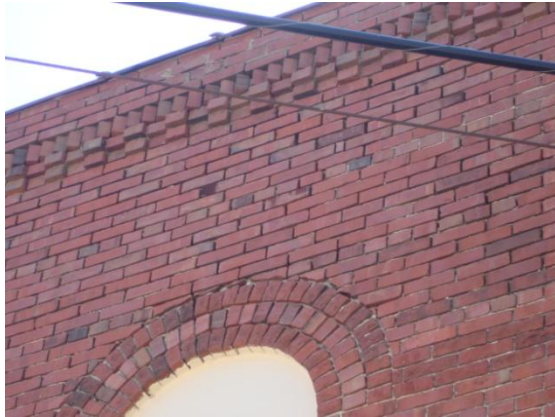
28. Masonry condition detail at one-story section of building, 1st Street façade.

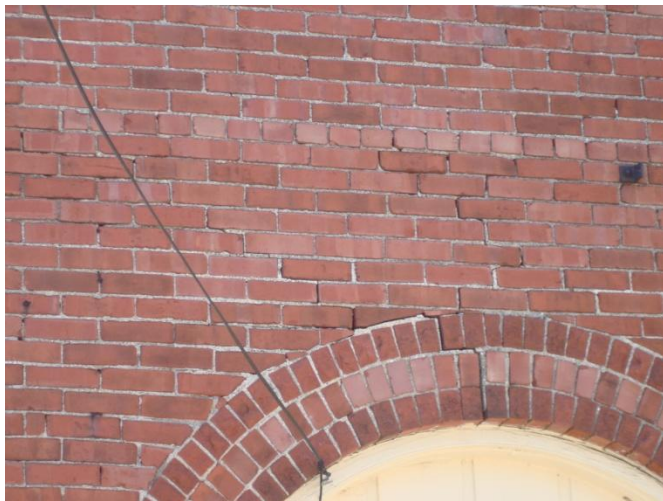
29. Masonry condition detail at one-story section of building, 1st Street façade.

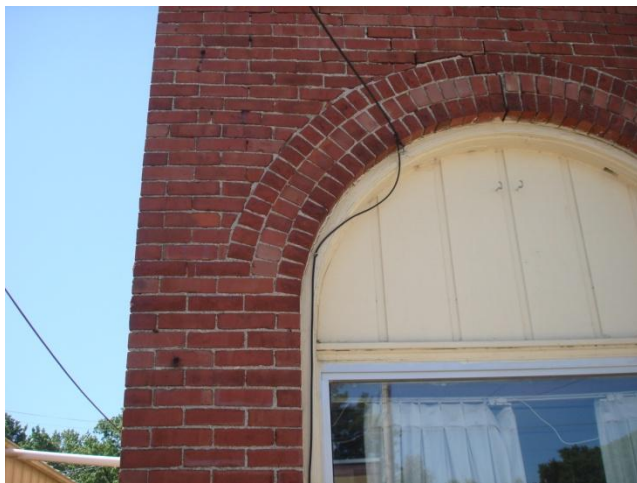
30. Masonry condition detail at one-story section of building, 1st Street façade.

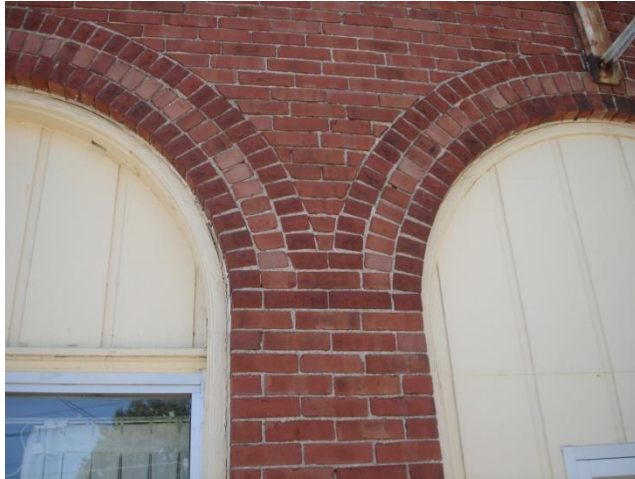
31. Masonry condition detail at one-story section of building, 1st Street façade.

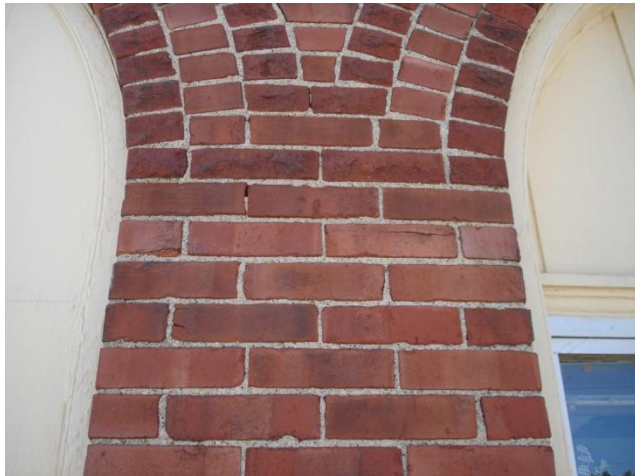
32. Masonry condition detail at one-story section of building, 1st Street façade.

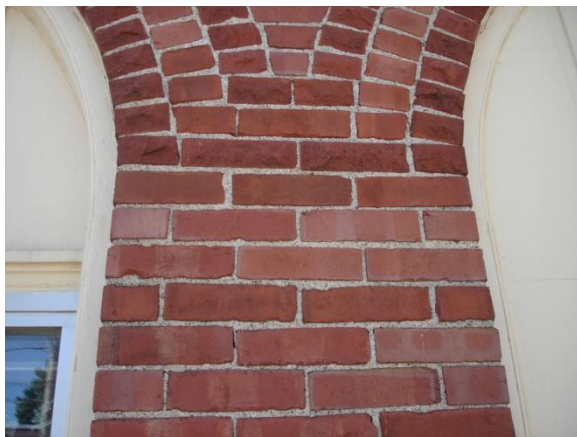
33. Masonry condition detail at one-story section of building, 1st Street façade.

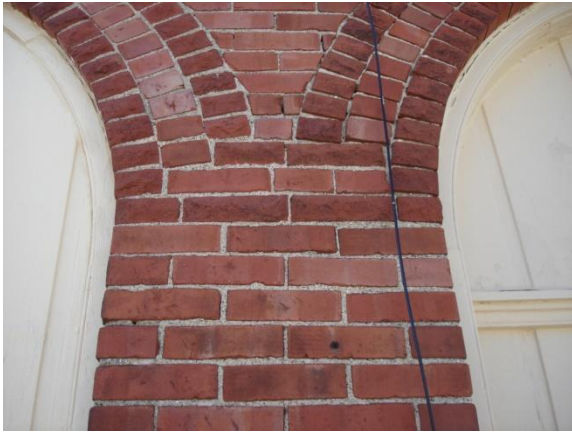
34. Masonry condition detail at transition from one- to two-story sections of building, 1st Street façade.

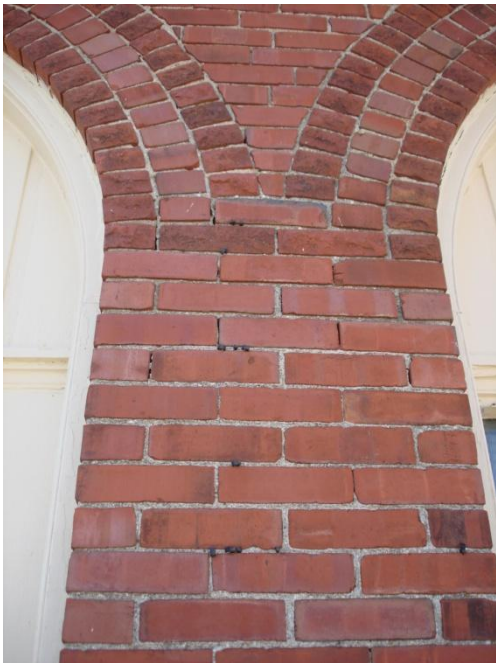
35. Masonry condition detail at two-story section of building, 1st Street façade.

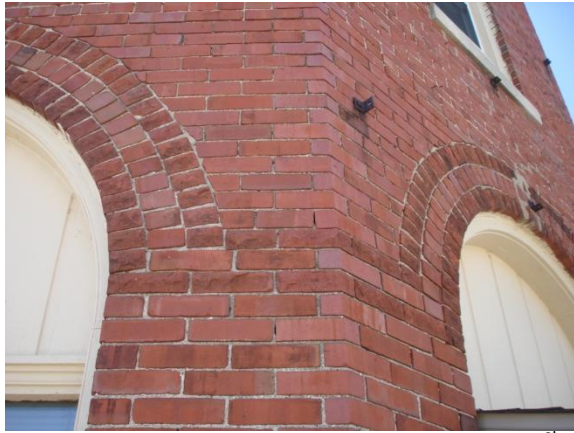
36. Masonry condition detail at corner of building, 1st Street façade.

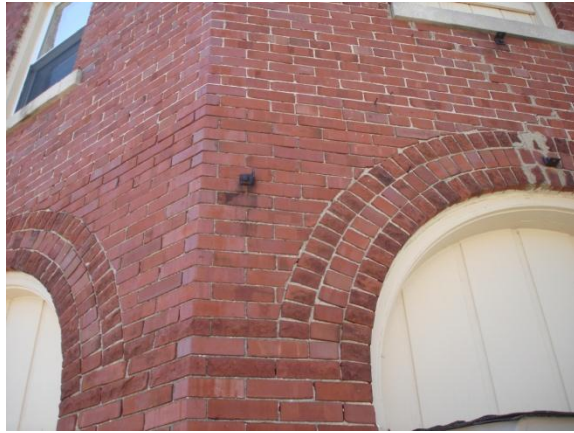
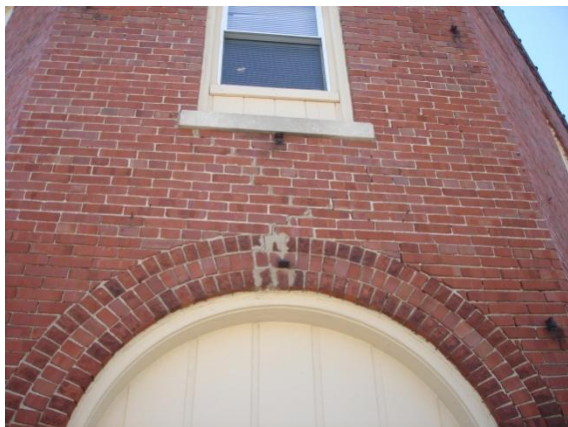
37. Masonry condition detail at corner.
